2019 DAM INSPECTION REPORT WOODLAND LAKE DAM

Submitted to:
ORGANIZATION OF WOODLAND LAKE
c/o Anita Grapentien, President
P. O. Box 617
Brighton, MI 48116-0617
agrapentien@comcast.net

Submitted by:
J.E. TIFFANY AND SONS, LLC
1707 N. 39 Road
Manton, MI 49663

November, 2019

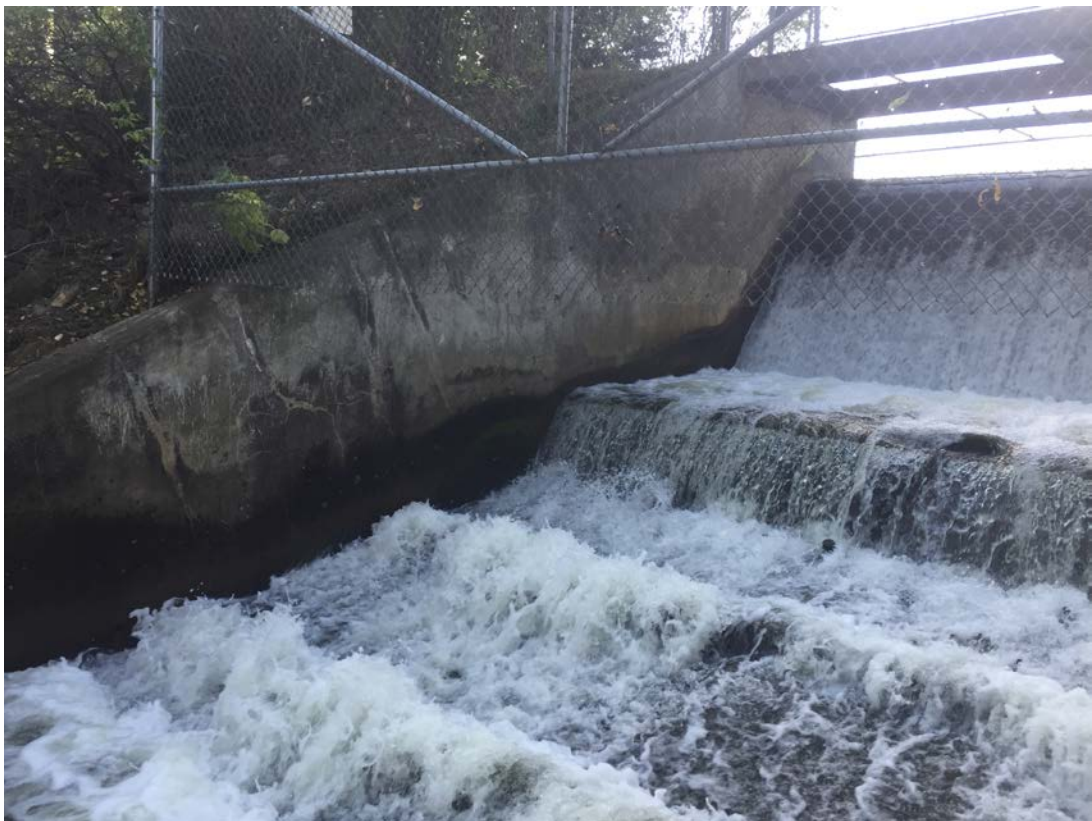
Spillway

No work is recommended for the spillway at this time.

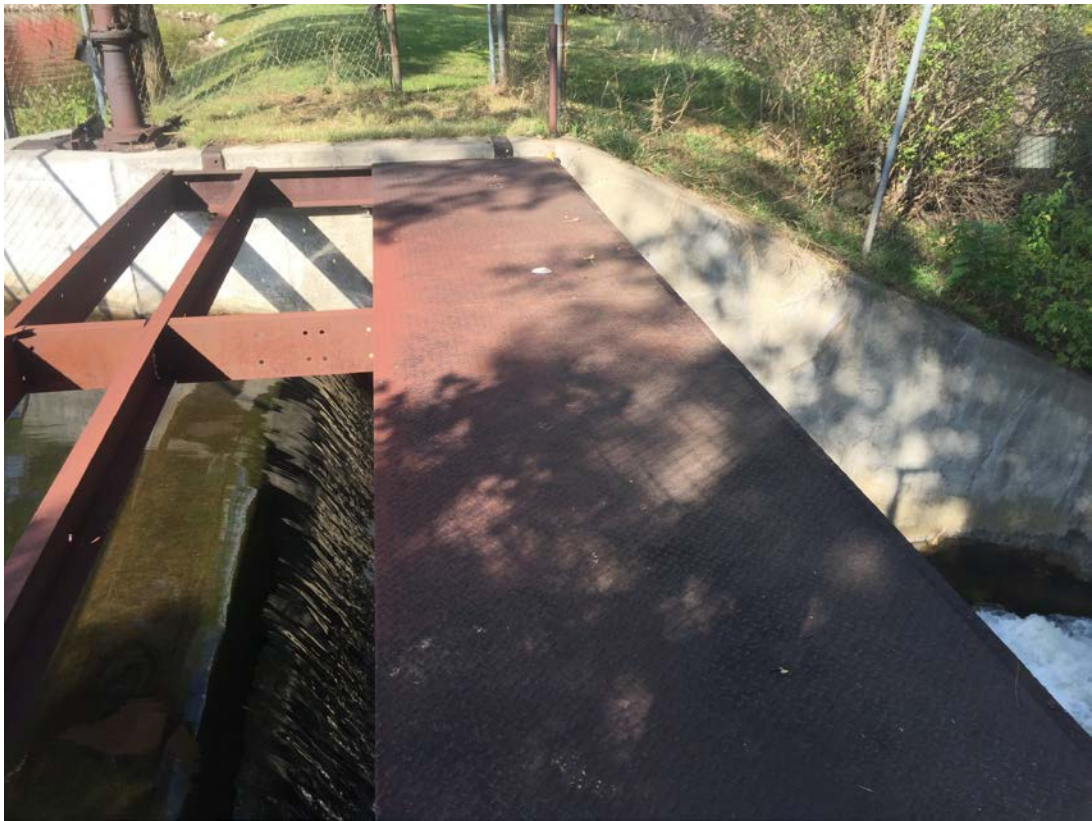
A pedestrian bridge/catwalk over the spillway is constructed out of steel and is in good condition. There is a chain link fence around the spillway that is also in good condition.

Bridge Over Spillway

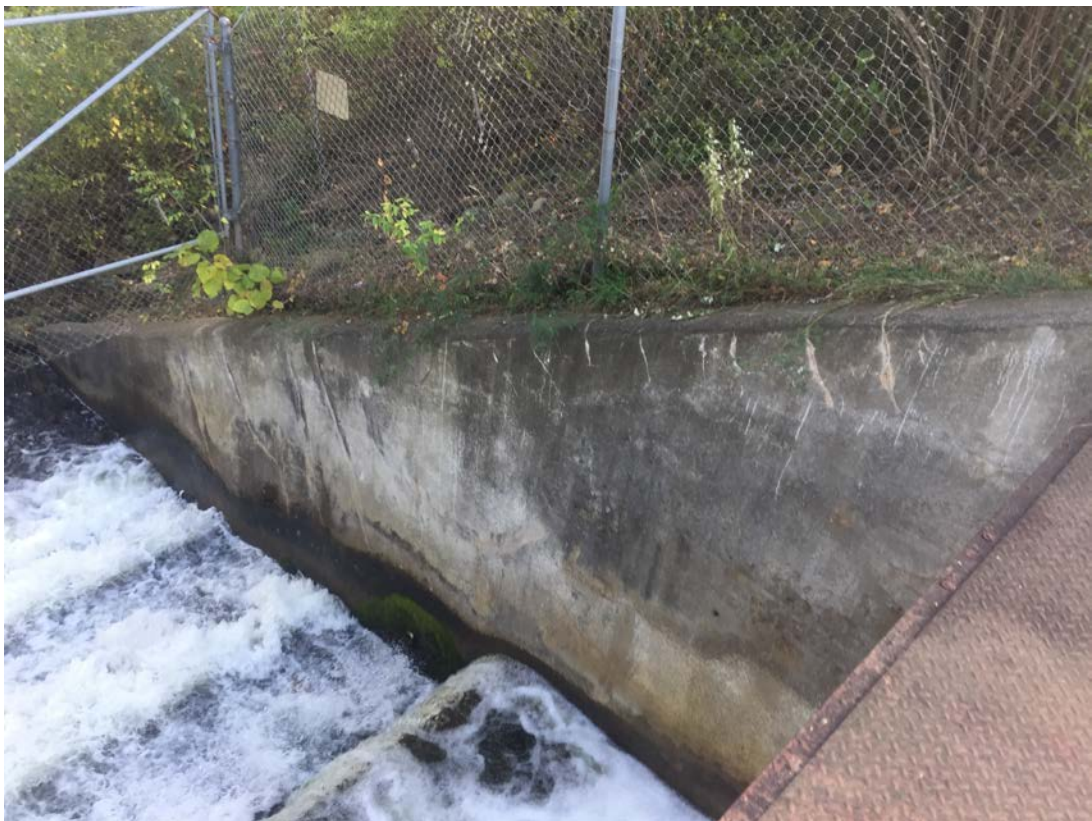
Training Walls- Concrete is in fair condition. Some cracking and moisture and/or efflorescence at cracks. Downstream face, left side is quite deteriorated.

Right Spillway Wall

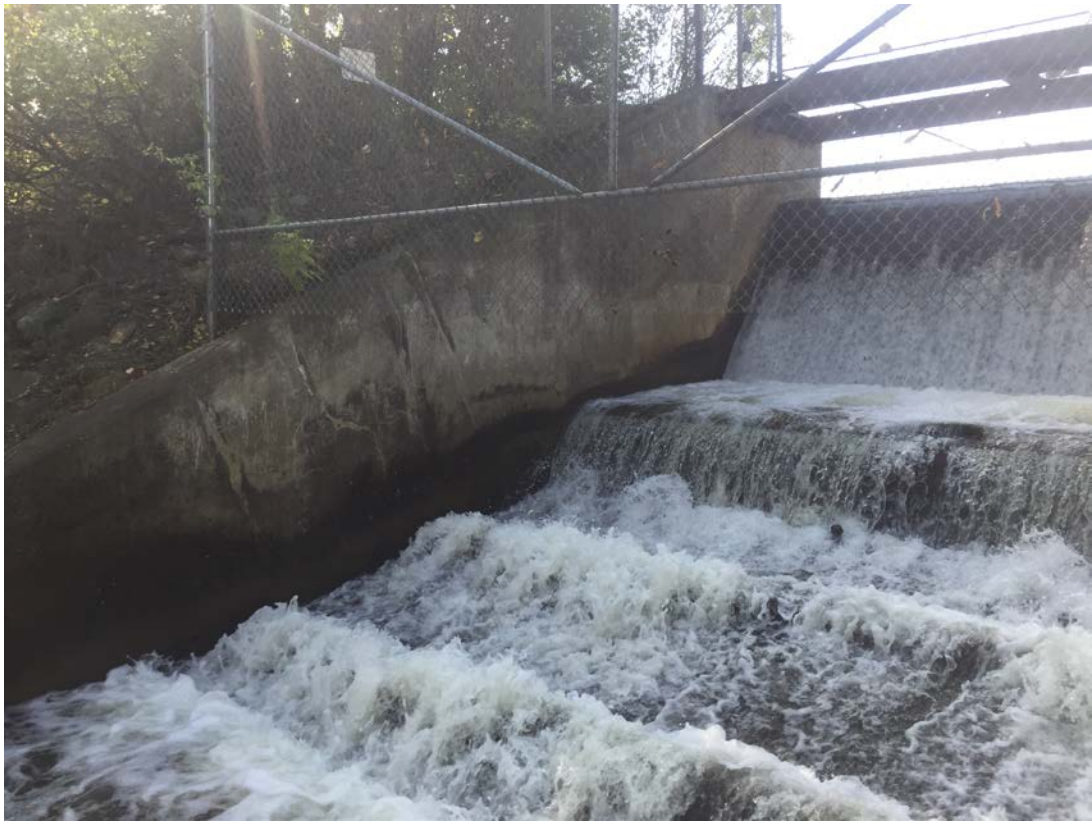
Right Spillway Wall

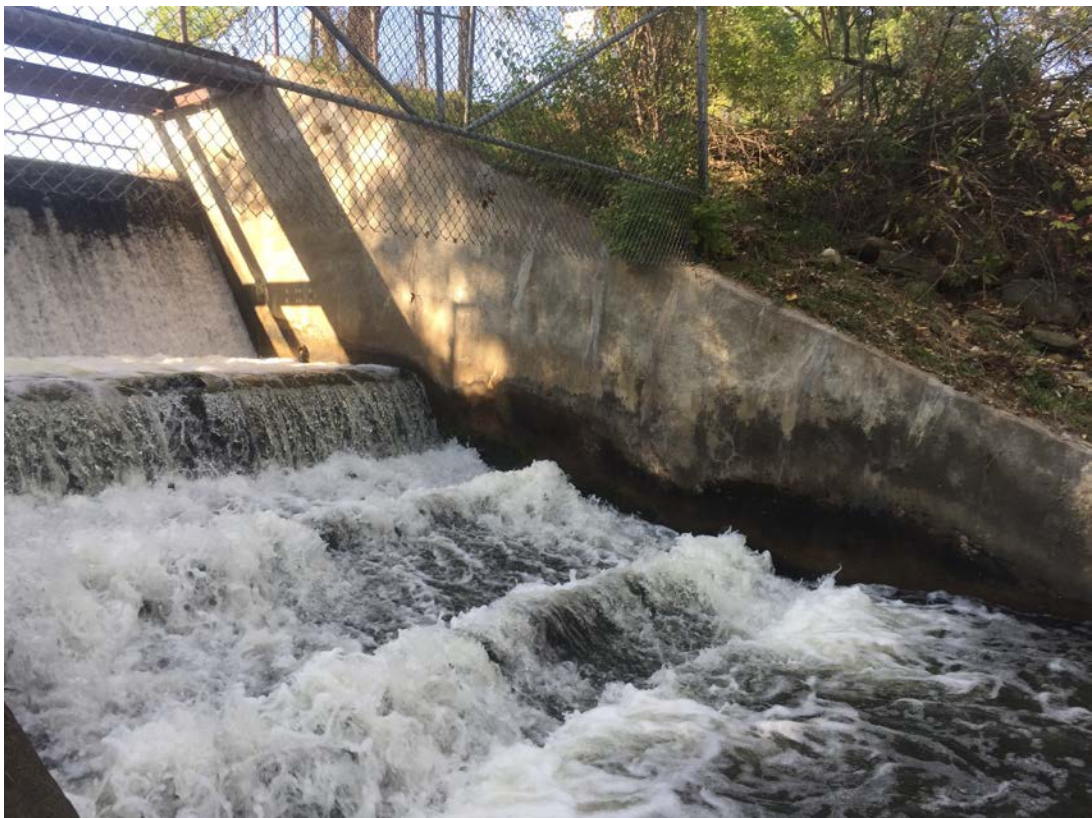
Left Spillway Wall

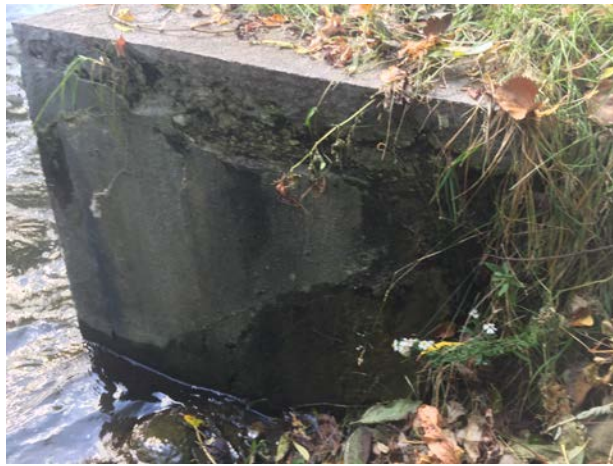
The spillway is in good condition overall. There are three relief wells in the bottom slab of the spillway approximately 2/3 of the way down. These were installed because of a previous concern about hydrostatic forces below the spillway slab. Organization of Woodland Lake Dam Committee members report that these wells discharge almost no flow when uncapped. The spillway side "training" walls were repaired in 2003 with the unsound concrete being chipped away, additional reinforcing steel being installed and the walls re-surfaced with an application of "shotcrete". The wall surfaces are showing evidence of cracking with some moisture and/or efflorescence exhibited at the cracks. The downstream end of the left wall is significantly deteriorated.

Downstream End of Left Wall

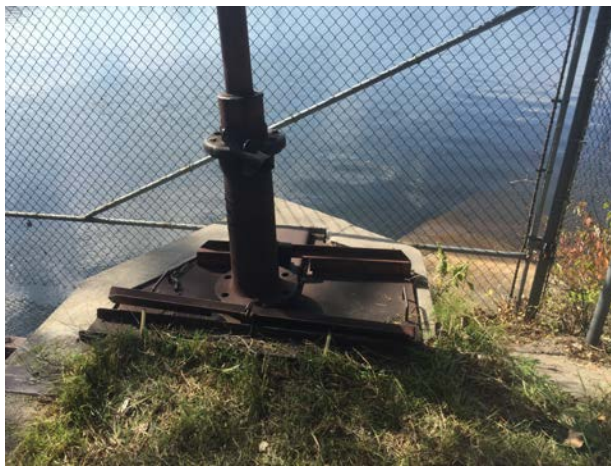
This dam has no operating equipment except the slide gate which appears to be in good condition. The Organization of Woodland Lake has written procedures for operating the spillway valve. They include: with whom the “turning arms” are kept, how to unlock the slide gate and how high to raise the rising stem to allow maximum outflow.

Slide Gate Operator

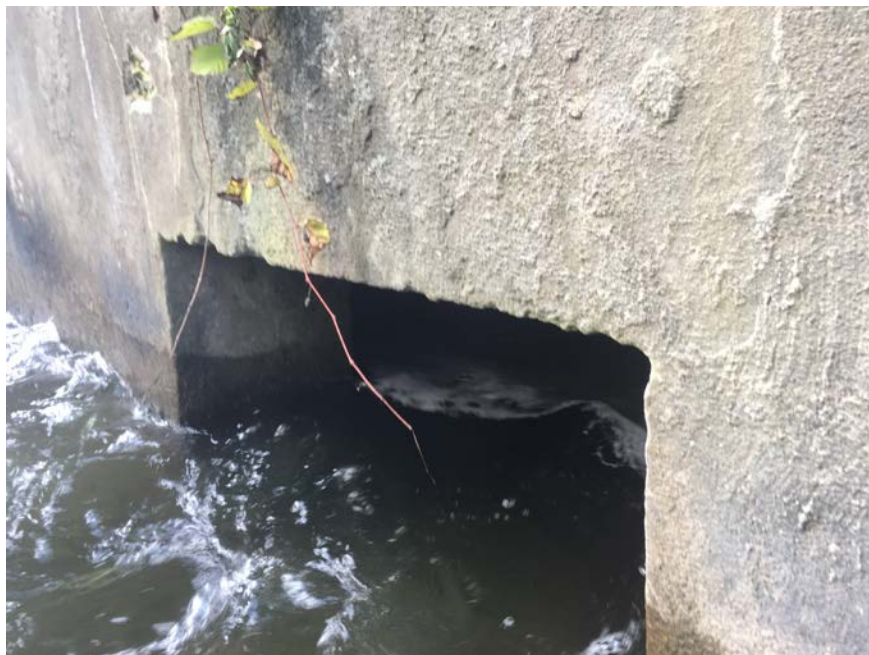
There is a low level slide gate reported to be 30 inches at the upstream end of a concrete tube that conveys water to the downstream end of the left spillway wall and can be used for drawing down the lake if necessary. The slide gate has an operating system with a rising stem that can be used to raise the gate using a lever with a lifting nut. It is reported that this gate is exercised on an annual basis. This was completed just prior to the current inspection. The ceiling of the concrete tube at the downstream end has some spalling.

Downstream End, Low Level Discharge

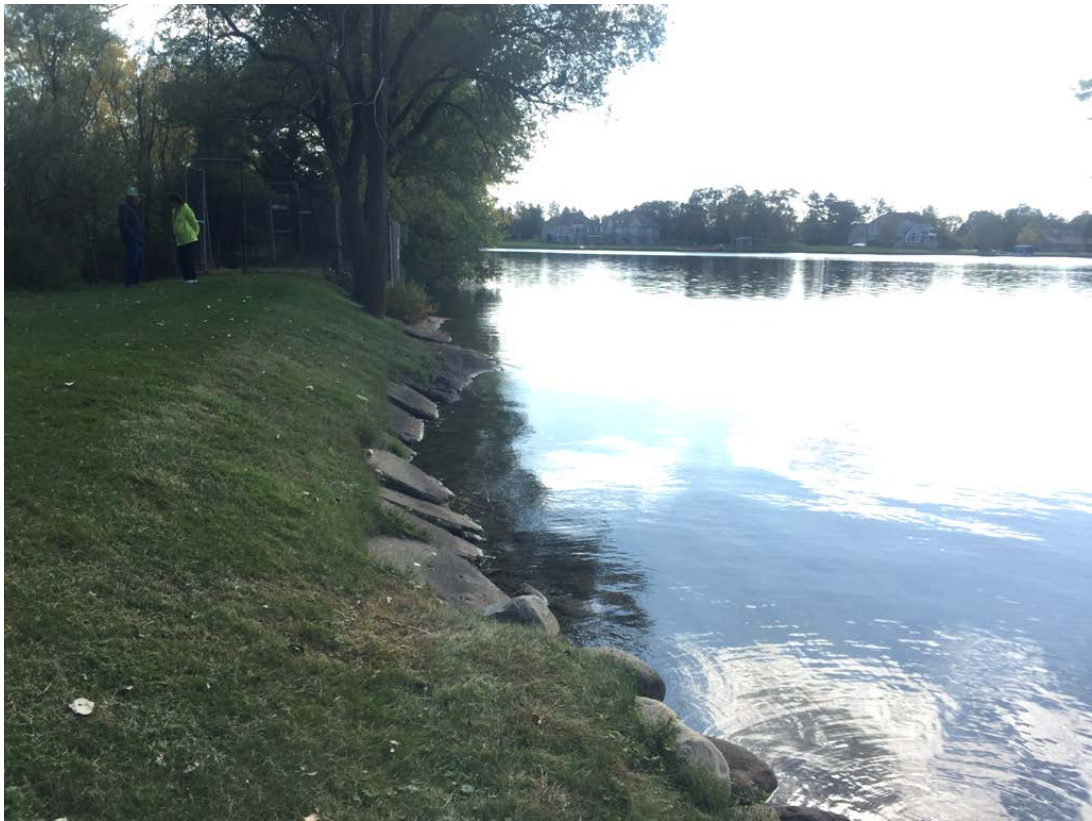
Main Embankment-Left of Spillway

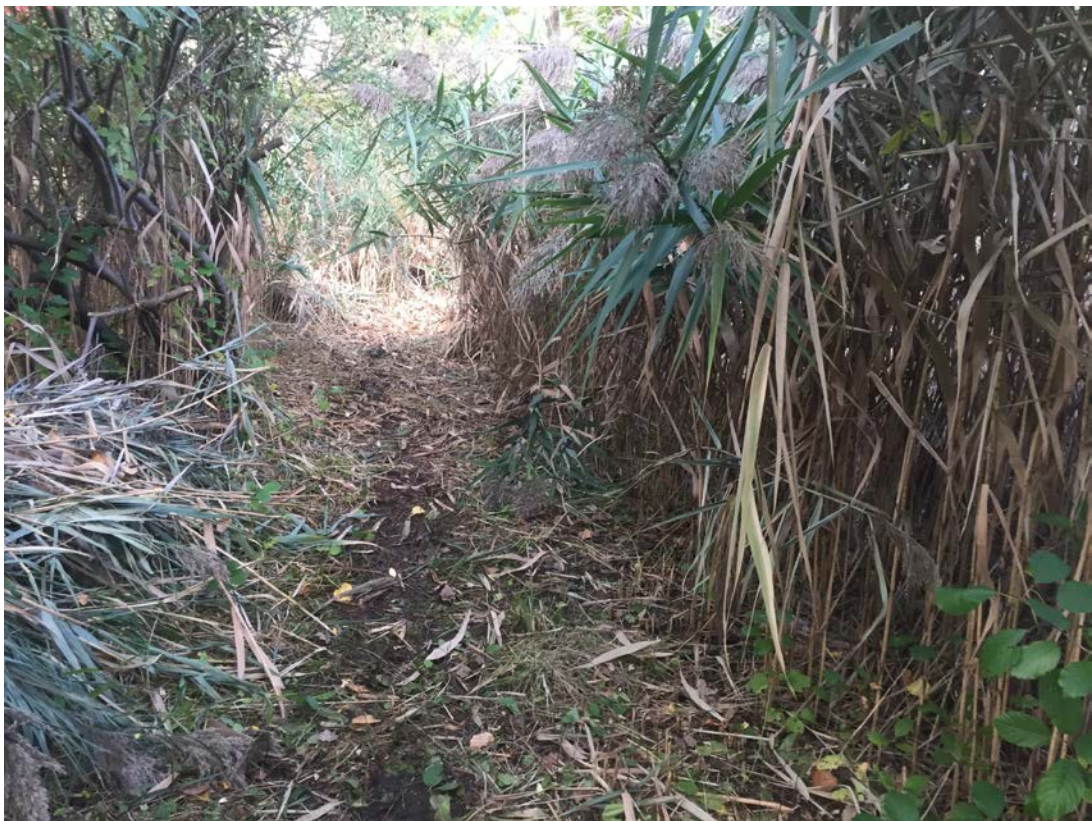
Main Embankment-Left of Spillway, Downstream

The upstream and downstream slopes are for the most part covered with trees and heavy brush. The crest is mowed periodically. It is recommended that an additional trail be mowed: near the downstream toe of the embankment.

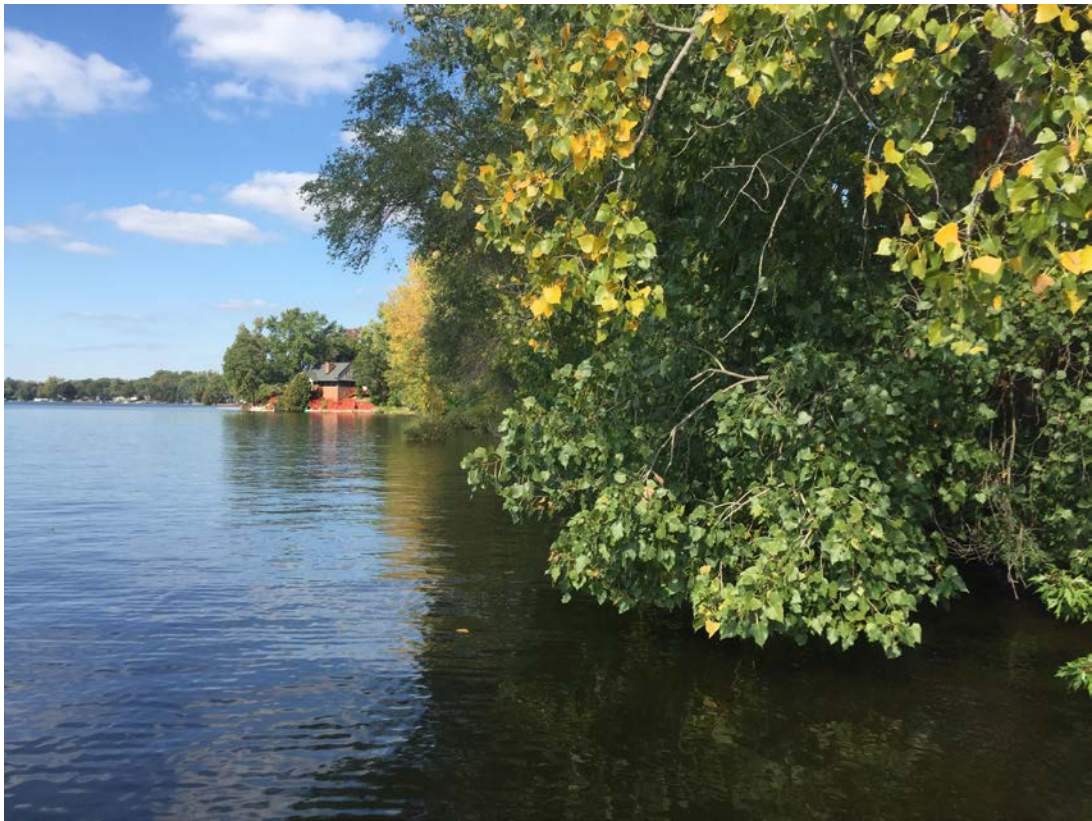
The upstream slope is well armored with poured concrete and rip rap for some distance above and below the normal water line. At the far right there is a wooden seawall protecting the embankment from wave action.

Main Embankment Shoreline, Right of Spillway

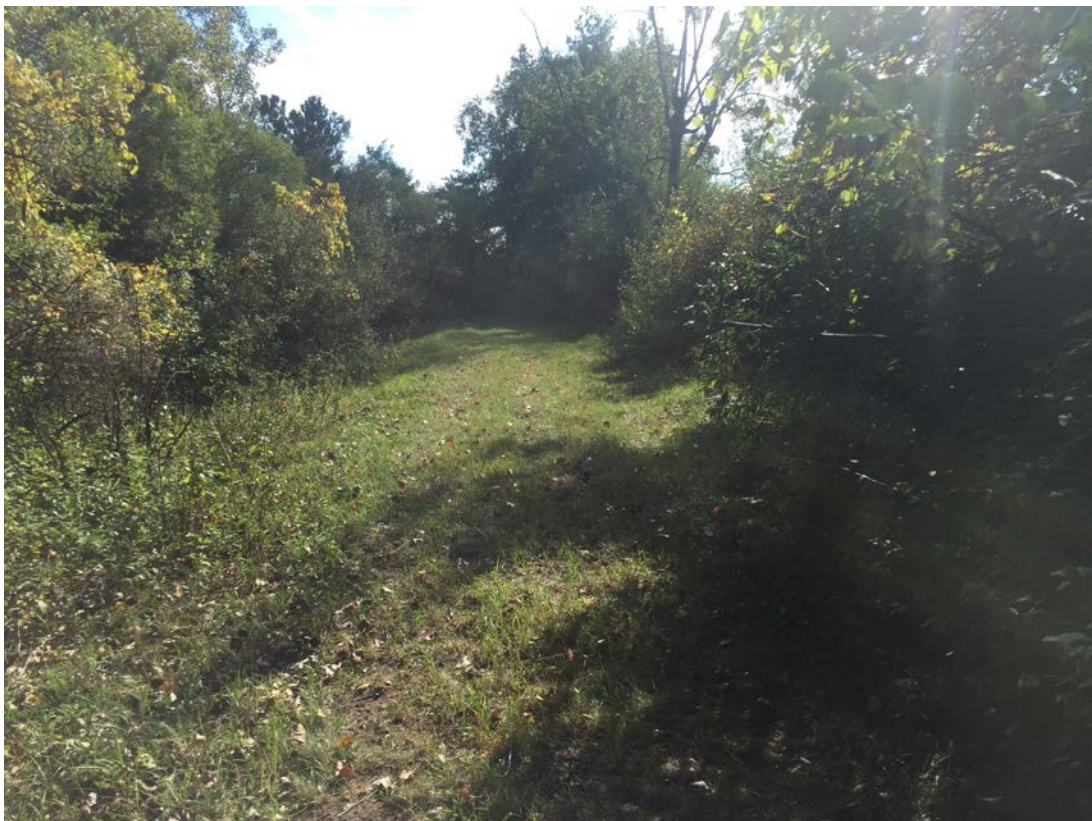
Main Embankment Crest, Right of Spillway

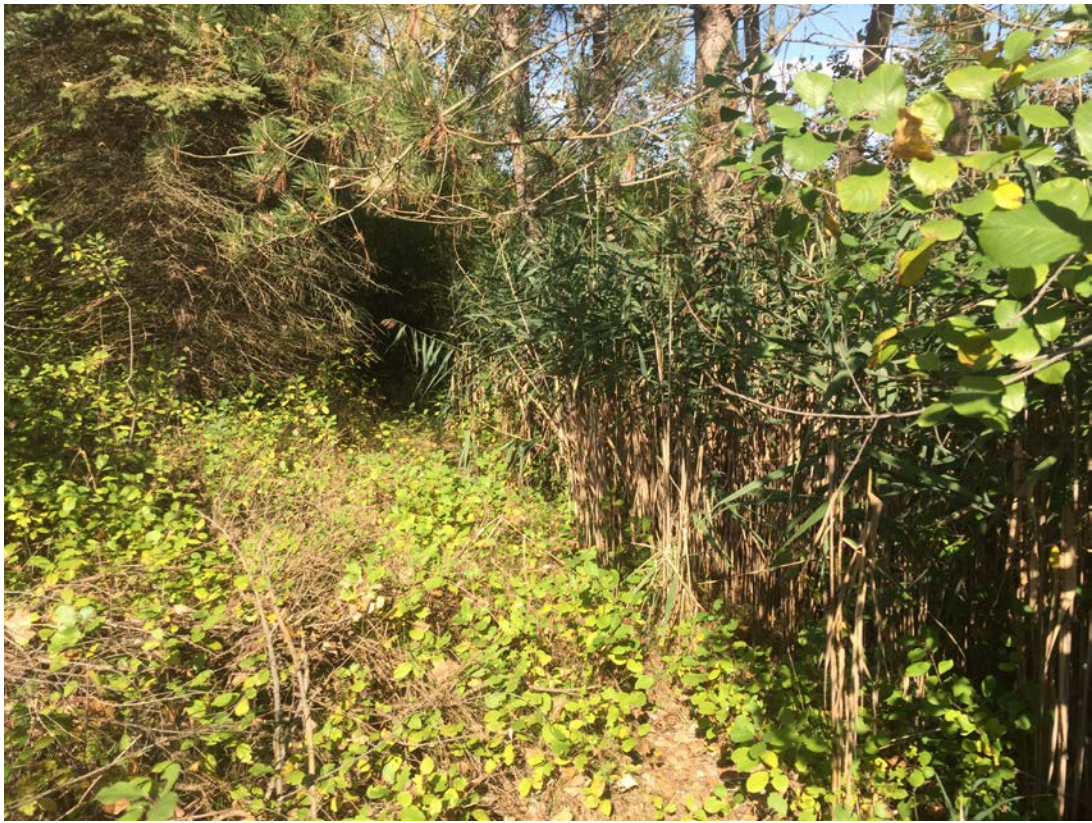
Saturated soil and wetland plants were noted about one third of the way up the embankment for about the right half of the embankment. Also saturated soil was noted at the toe area where the main embankment and causeway embankment meet. No seepage flow was noted in these areas. No recommendations, other than continued monitoring, are made at this time for the saturated soil areas.

Main Embankment-Downstream Slope, Right of Spillway

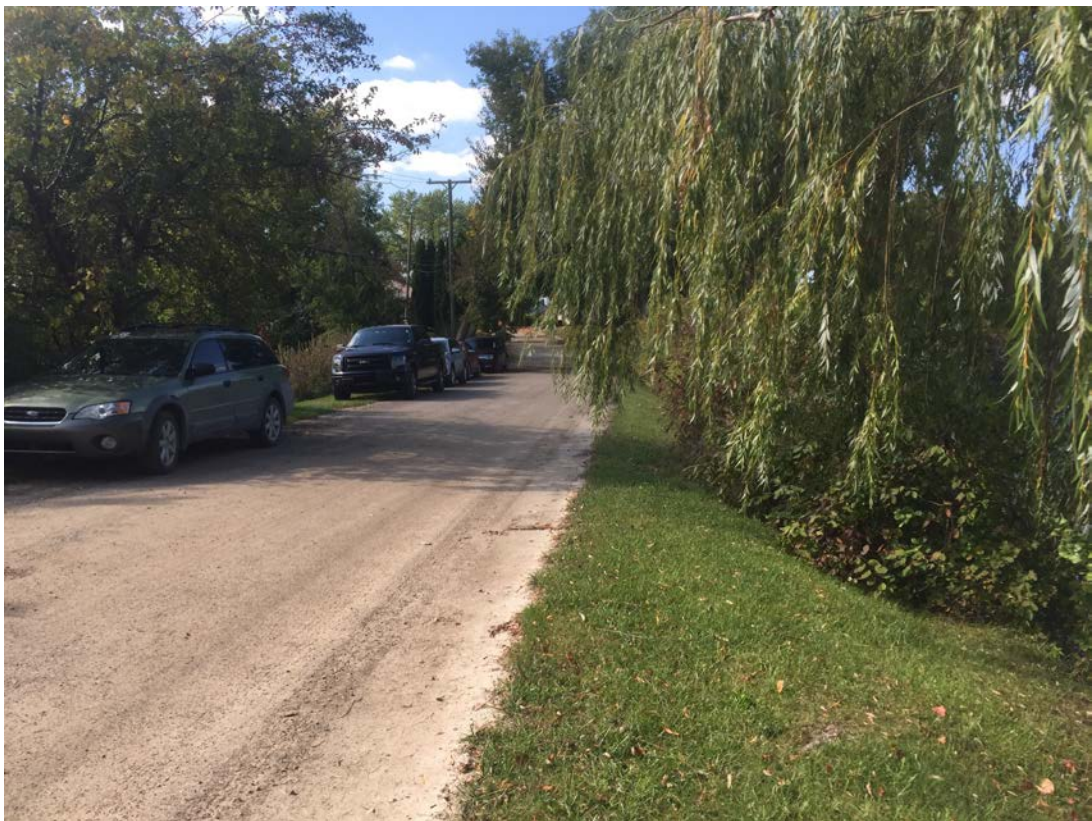
Causeway Drive

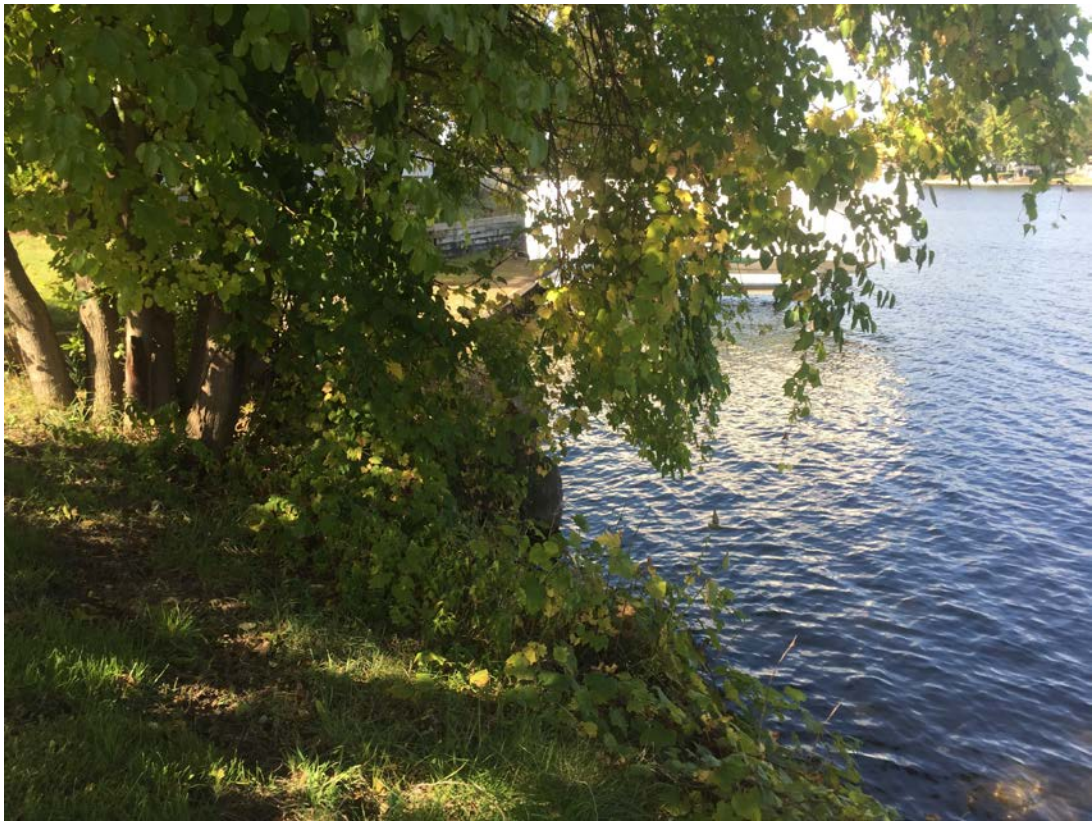
Causeway Along Shoreline

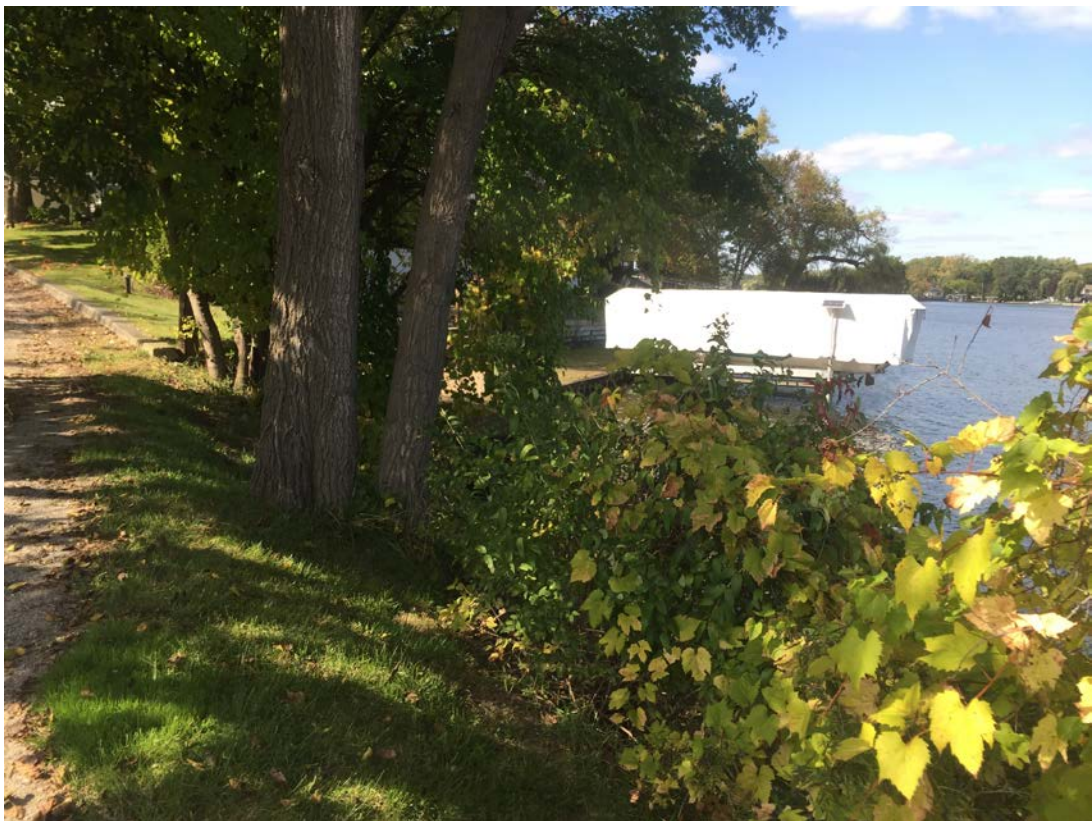
The upstream slope is well armored with poured concrete and rip rap for some distance above and below the normal water line.

Causeway Shoreline, Upstream Slope

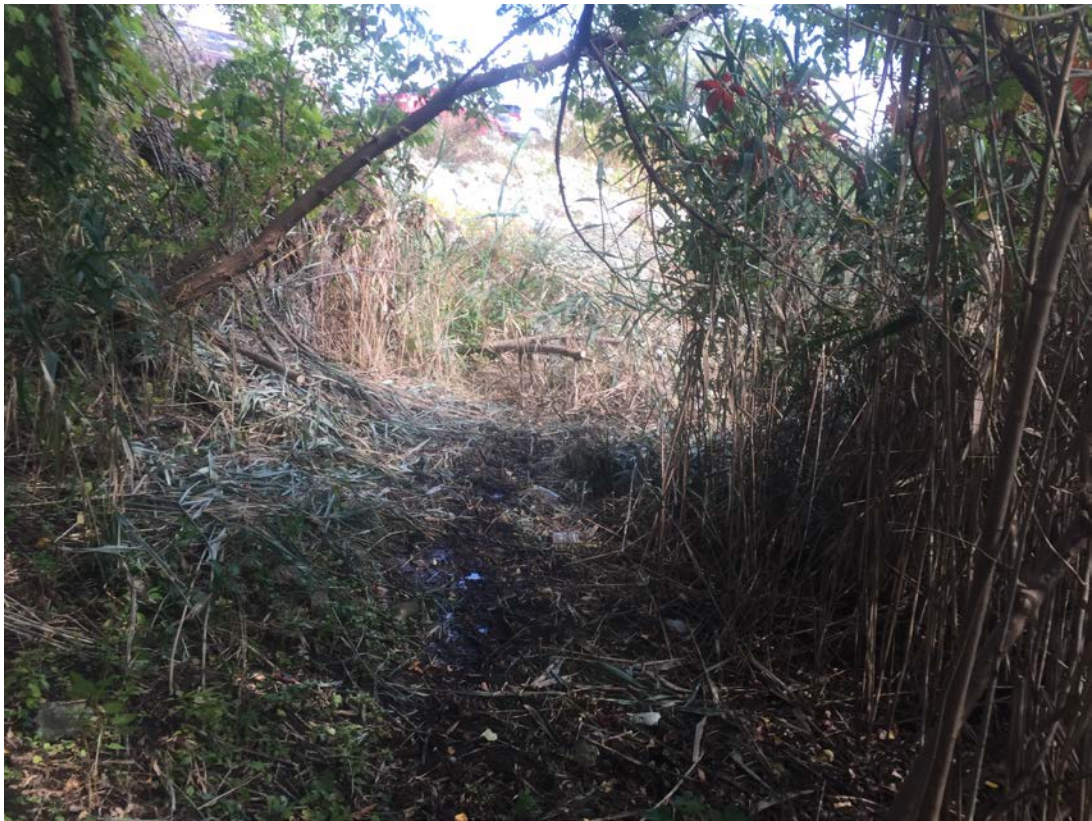
Saturated Soil, Downstream, Right End of Causeway Embankment

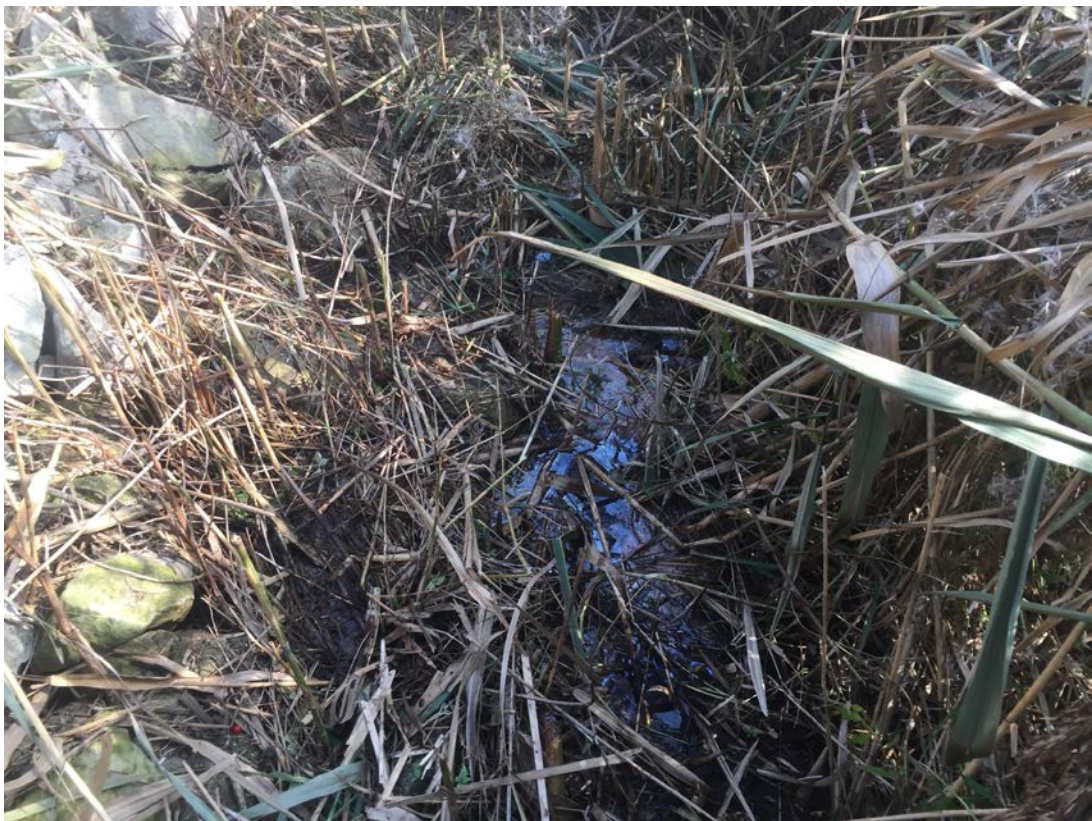
Saturated Soil at Toe of Causeway Embankment

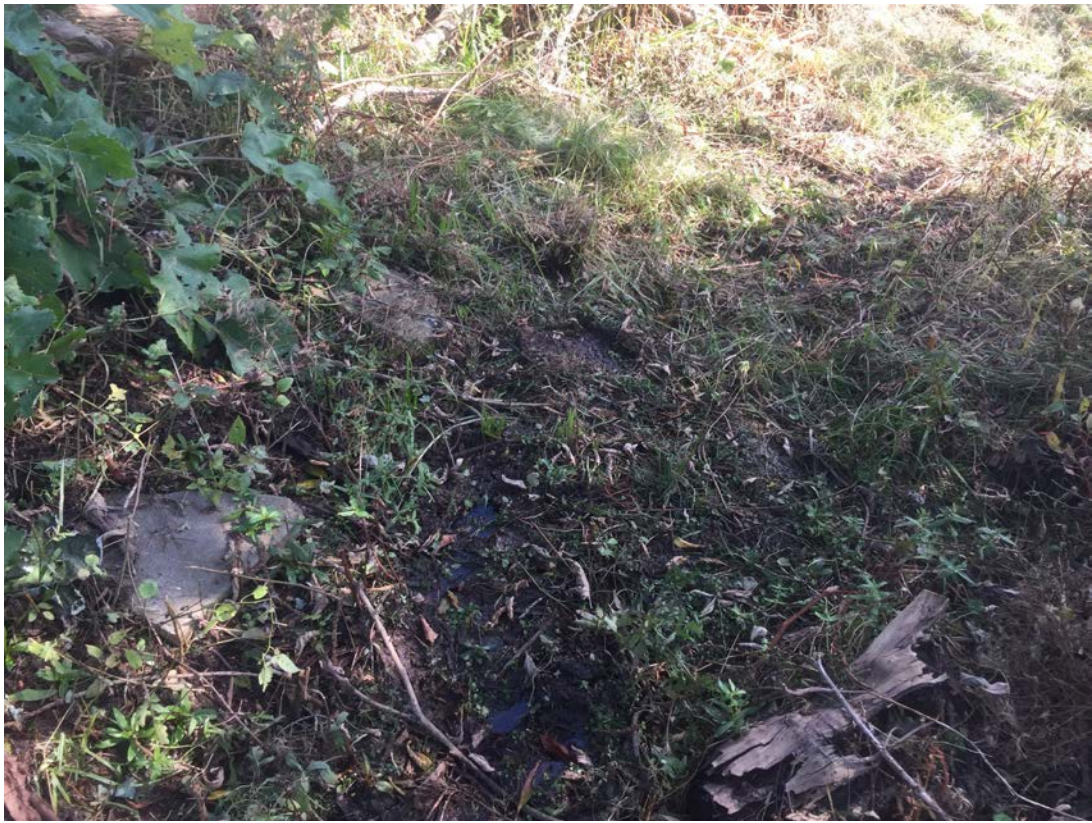
Saturated Soil at Toe of Causeway Embankment

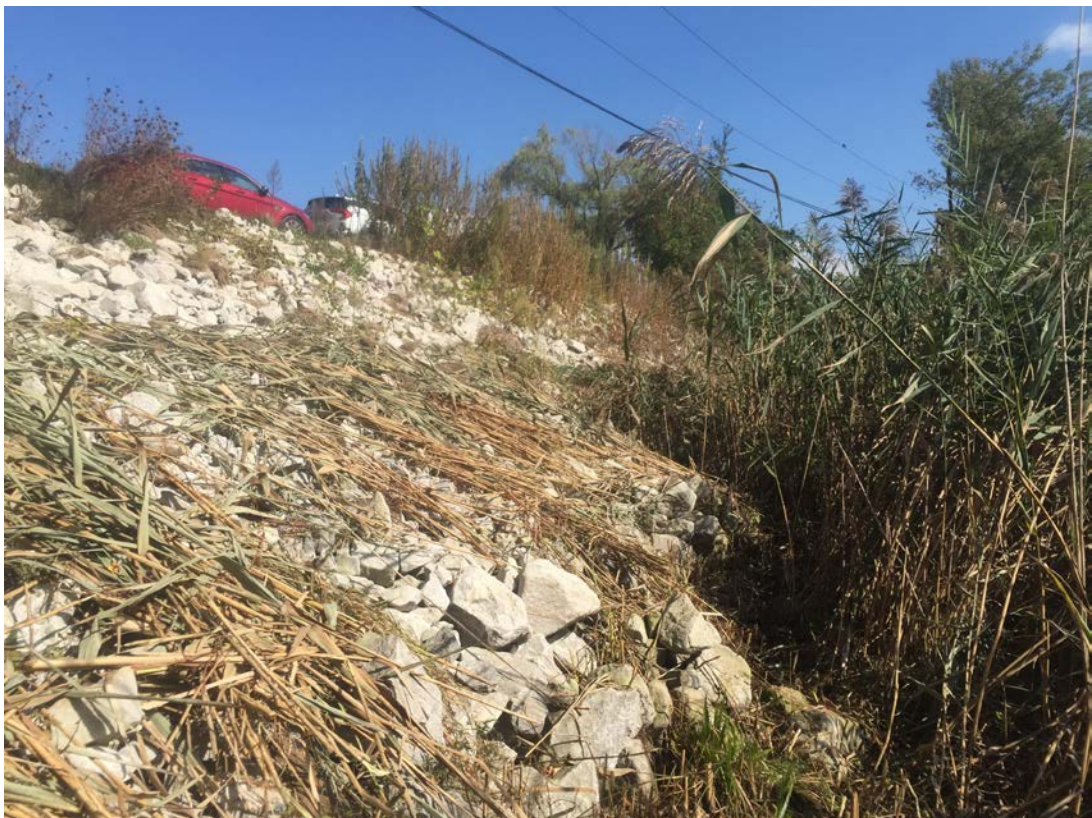
Embankment stability for the causeway embankment has been an issue of concern for several years. Prein & Newhof were hired as engineers to design stability improvements to the causeway embankment. Phase I of this work has been completed with a second (final) phase in the works.

Causeway Embankment Slope Treated with Riprap

Additional historical information about the stability of the causeway embankment is available in the 2013 inspection report. It is recommended that the Organization of Woodland Lake continue to move forward with the final phase of the causeway embankment work prior to the 2022 inspection.
